RUBIDIUM AND CESIUM FREQUENCY STANDARDS  
STATUS AND PERFORMANCE ON THE GPS PROGRAM  
HARRY BETHKE, DALE RINGER AND M. VAN MELLE

Rockwell International  
Satellite System Division  
Seal Beach, California

13. SUPPLEMENTARY NOTES <b>Proceedings of the Sixteenth Annual Precise Time and Time Interval (PTTI) Applications and Planning Meeting, Greenbelt, MD, 27-29 Nov 1984</b>

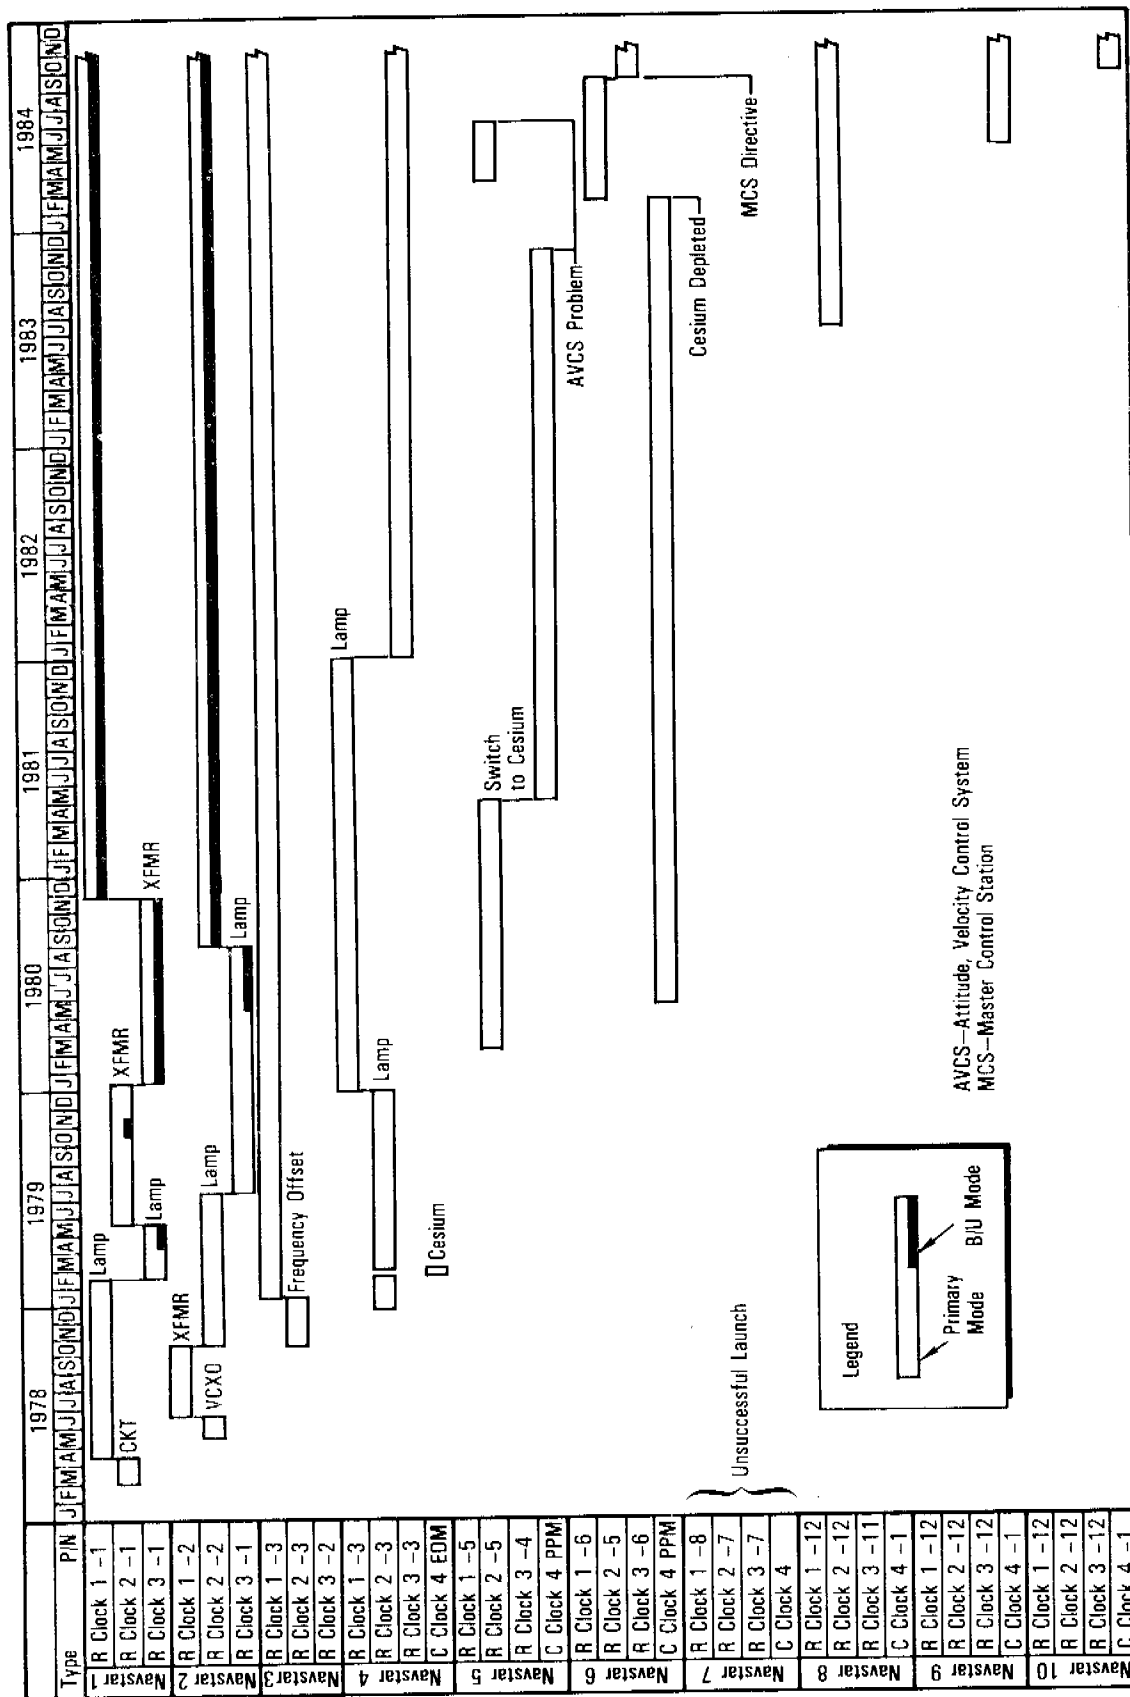
Figure 1. Navstar Clock Operating History

The evolution of the Rb frequency standards (RFS) on the GPS program started with the Block I concept validation program beginning with a proposal program in 1973, followed by the (GPS 1-8) prototype space vehicle contract in 1974. The full scale developmental (GPS 9-11) models, contracted in 1978, provided both navigation and nuclear detection capability. The production qual vehicle (GPS-12) was contracted in 1980, and the production vehicles (GPS 13-40) in 1982. During the proposal phase of this program, the on-board frequency standards were considered the most critical item within the GPS navigational system for achieving user position accuracy. Therefore, a considerable amount of effort was devoted to the frequency standards. To minimize the risk to the GPS program on this critical item, the initial GPS vehicles (GPS 1 through 3) incorporated three Rb frequency standards, each with a backup mode. This was achieved by operating a high performance VCXO without Rb reference. This design concept resulted in the redundancy potential of six frequency standards per vehicle. Later space vehicles, starting with GPS 4, included an additional cesium frequency standard, also with a backup VCXO mode. This extended redundancy was deemed necessary in lieu of the more conventional dual redundancy. The actual on-orbit GPS frequency standard operating history, shown in Figure 1, illustrates the results of this hardware implementation.

On-orbit operation data of GPS Rb frequency standards started with Navstar 1 in March, 1978, followed by Navstar 2 in May, 1978. The original Dash 001 part number clocks were used in Positions 1, 2, and 3 on Navstar 1 and in Positions 3 on Navstar 2. Dash 002 clocks were used in Positions 1 and 2 and Navstar 2. The only difference in the Dash 002 from the Dash 001 clocks was a time constant change in the servo control loop. As shown in Figure 1, three types of problems were experienced:

1. Power supply transformer failures
2. Lamp failures
3. Low frequency oscillation of the VXCO heater control

The new transformer was installed in all Dash 003 and subsequent clocks. Results of this change are very apparent from the data shown on Table 1. A total of 186 months (15.6 years) of on-orbit operation have accumulated with no transformer failures. Referring to Figure 1, note that Frequency Standard 1 on Navstar 3 has been operating continuously for 70 months (approximately six years); this provides a very high degree of confidence that the transformer problem has been corrected.

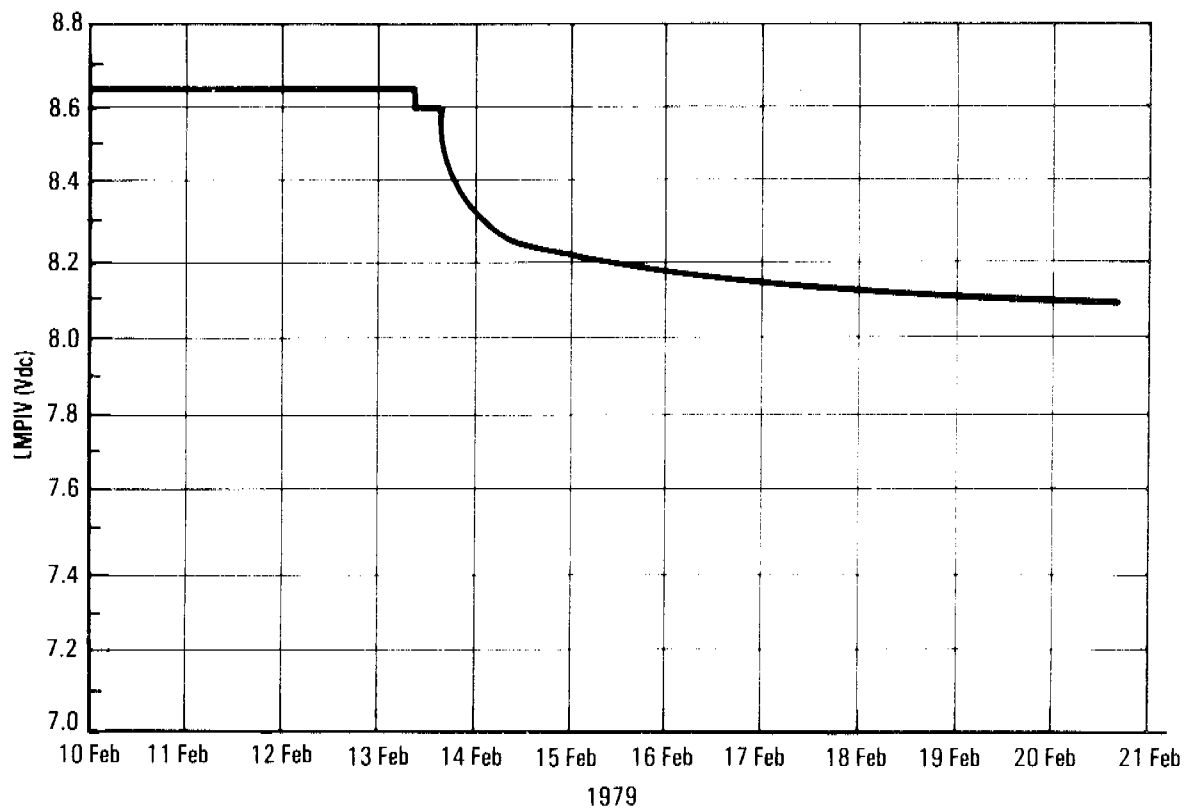
Figure 2. Navstar 1 Frequency Standard No. 1 LMPIV Anomaly

The Rb lamp failures were perhaps the most critical on-orbit problem encountered on the early space vehicles. To investigate the problem, a team was assembled that consisted of representatives from Rockwell, the National Bureau of Standards, Duke University, the USAF, Aerospace Corporation, and Efratom. Once the clock failure was established to be the lamp, a plan was initiated to duplicate the on-orbit failures in the laboratory. Lamps were prepared with an intentionally low Rb fill, installed into the physics packages, and subsequently installed into several frequency standards. Laboratory testing on these standards duplicated the on-orbit lamp failures. All units exhibited the same lamp voltage decay characteristics symbolic of the suspected lamp failures as illustrated in Figure 2.

To determine the amount of Rb in the lamps, a three-fold corrective plan of action was instituted:

1. For Rb lamps already built, the fill would be determined by neutron activation.
2. The fill of newly fabricated lamps would be determined by sampled destructive analysis.

3. A calorimetric measurement utilizing a differential scanning calorimeter is now used.

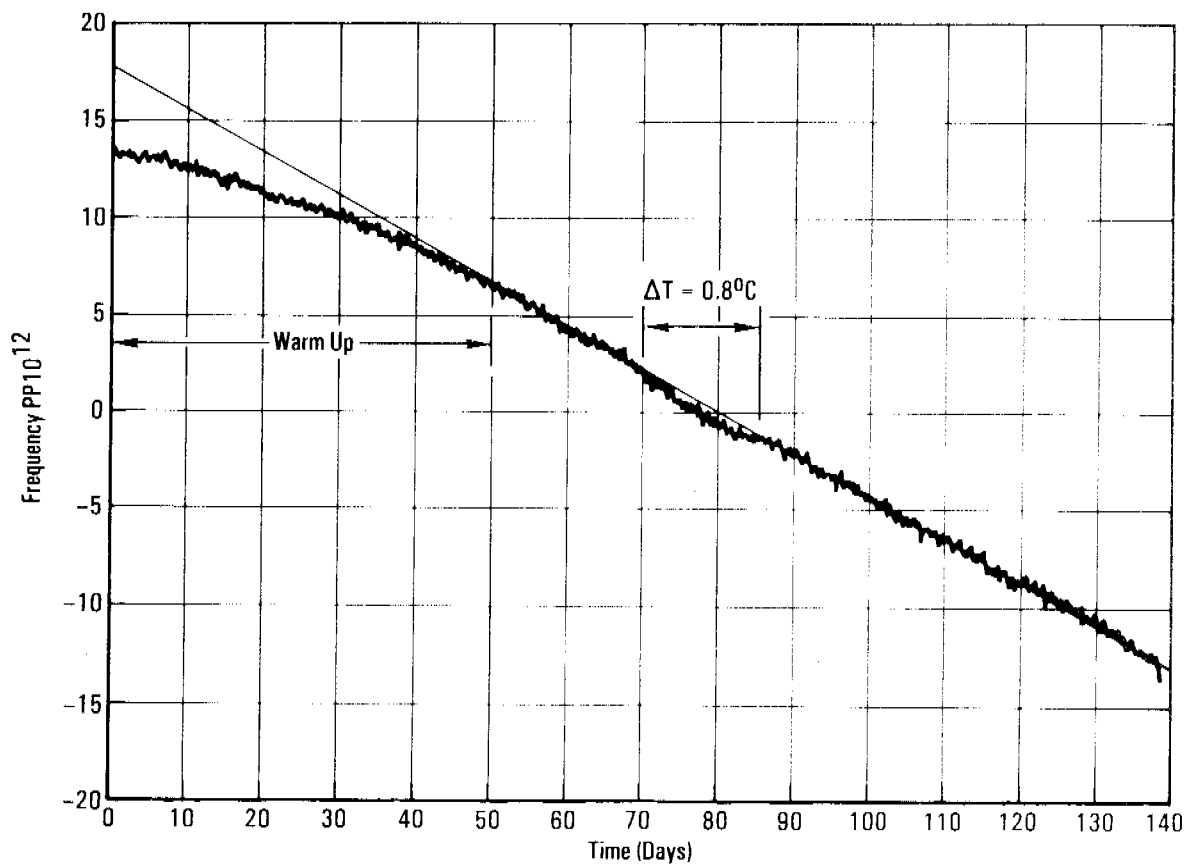
Figure 3. GPS 140-day Rb Stability Test

The beat frequency,  $\Delta f/f$ , is shown in Figure 3. The frequency was calculated from 1,000-second period average data, which was then averaged over 10 data points to conform to computer storage requirements. Examination of the entire 140-day period shows an initial "warmup" period of about 50 days, during which the drift changes from about minus  $6 \times 10^{-14} \Delta f/f/\text{day}$  to minus  $2 \times 10^{-13} \Delta f/f/\text{day}$ . The frequency drift is relatively constant from Day 50 to Day 140, except for a dip from Day 70 to Day 86. This dip correlates to a drop in the clock baseplate temperature of about  $0.8^\circ\text{C}$ . This points out the critical role that temperature stability plays with frequency and time prediction error.

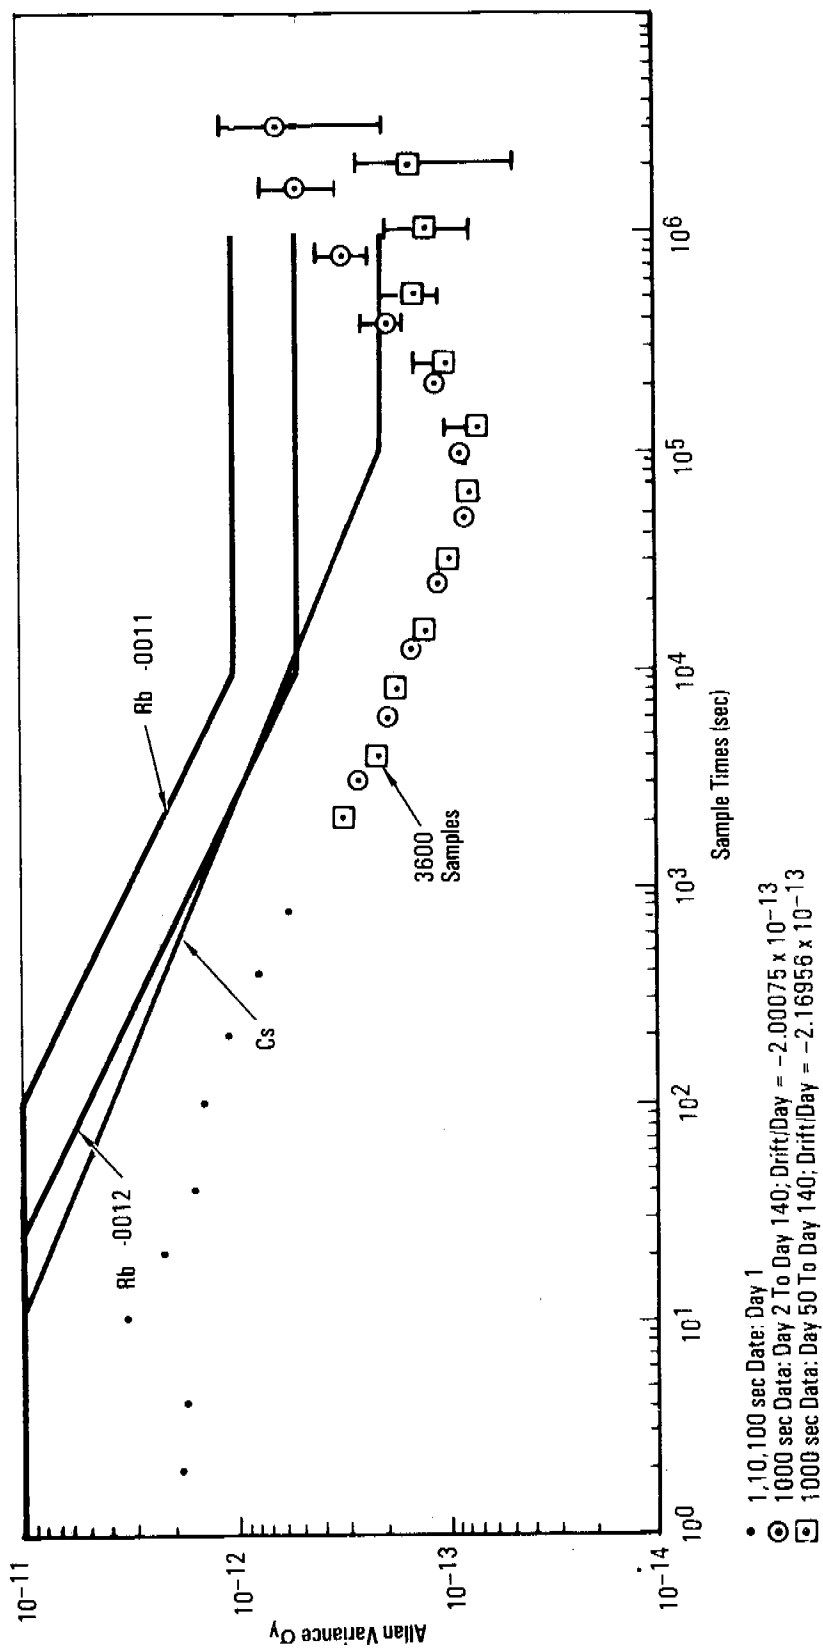
Figure 4. IR&D Time Error 140-day Stability Test Rb Frequency Standard No. LQX0001

The Allan variance,  $\sigma_y$ , can be calculated both with and without the warmup period data. It can be seen in Figure 4 that the main effect of the behavior is on the long-term values or the "random walk." The total data  $\sigma_y$  represents the usual RFS Allan variance signature; whereas, the day 50-150  $\sigma_y$  values are better in terms of random walk. If  $\mu$  is the slope of the random walk portion of the Allan variance plot where  $\sigma_y \sim t\mu$  for large  $t$ , then  $\mu = 0.7$  for Day 0 to Day 140 data, and  $\mu \approx 0.1$  for Day 50 to Day 140 data.

Excluding the data which was affected by the warmup or temperature change, the time prediction error is found to be very small. This points out the importance to the time error of small temperature changes to the RFS. Since the on-orbit Rb standards now have a baseplate temperature controller that controls the clock temperature to within  $\pm 0.1^\circ\text{C}$ , excellent time error values on orbit are expected as evidenced in Navstar 8.
